## CASE STUDY

### Stormwater Drain Relining

## Stormwater Drain Joint Repairs

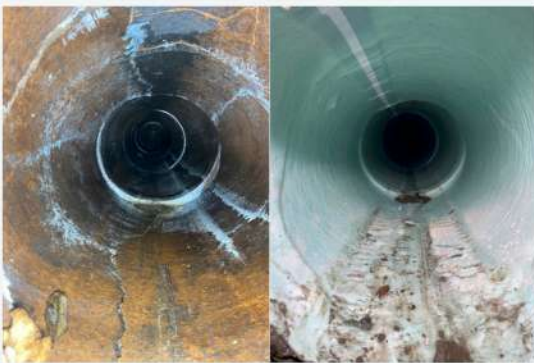
Pre & Post Lining

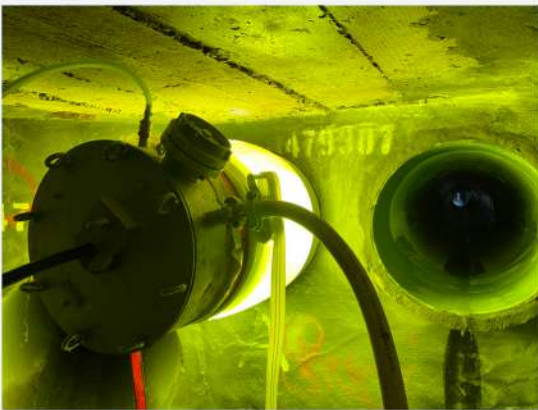
UV Liner in place curing
